**Muirfield HOA
ARC Association Reserve Consultants, Inc. Summary**

ARC RESERVE STUDY SUMMARY	
Association: Muirfield HOA	No. 1187-001
Location: Heber City, Utah	
No. of Units: 196	
Report Period: 1/01/2012

The property consists of a sewage lift station, park/playground, asphalt parking, and common area landscaping.

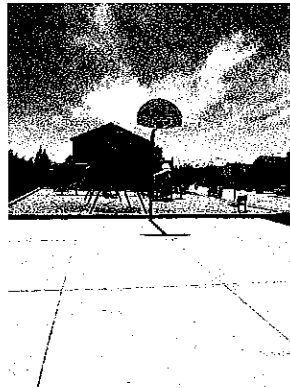
Concrete-Repair - 2013

We have budgeted for a percentage repair/replace of the concrete curbing at the parking areas and park. The condition of the concrete should be monitored and the budget adjusted accordingly.

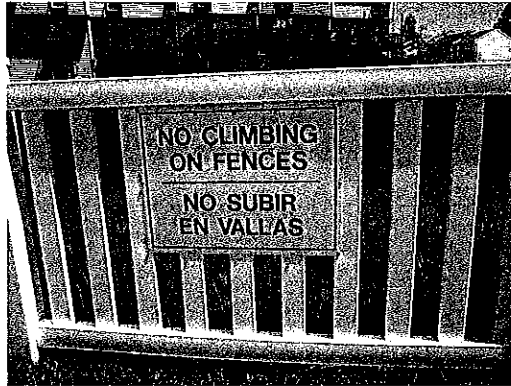
Signs-Metal, Information, Repl - 2014

These signs are 2.5'x2.5' and are located in the parking areas and along the fence.

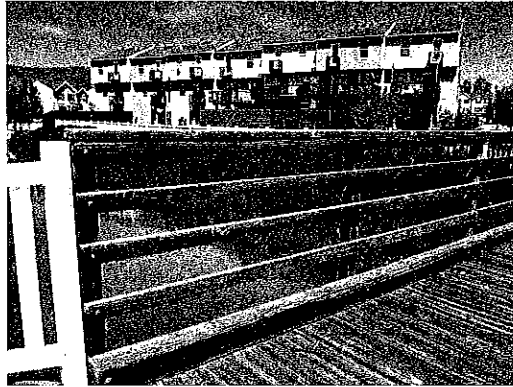
Bridge-Wood, Rpl continued...

This bridge is 6'Wx24'L with 4 horizontal rails

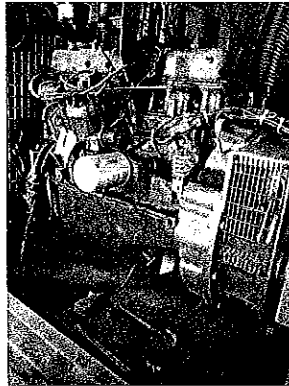
Generator-Stand-by, Nat. Gas, Replace - 2019

This is for a 35 KW unit. Its life is estimated based on repair parts being obsolete and not available in 20 years and not for a typical 4,000 hours of run time.

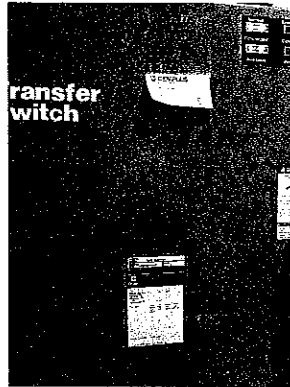
Generator-Transfer Switch, Repair continued...

This is for a 200 amp switch

This is covered under the annual maintenance agreement.

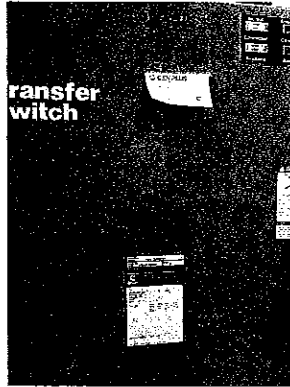
Generator-Transfer Switch, Rpl. continued...

This is for a 200 amp switch
