**Muirfield HOA
ARC Association Reserve Consultants, Inc. Summary**

ARC RESERVE STUDY SUMMARY	
Association: Muirfield HOA	No. 1187-001
Location: Heber City, Utah	
No. of Units: 196	
Report Period: 1/01/2012

The property consists of a sewage lift station, park/playground, asphalt parking, and common area landscaping.

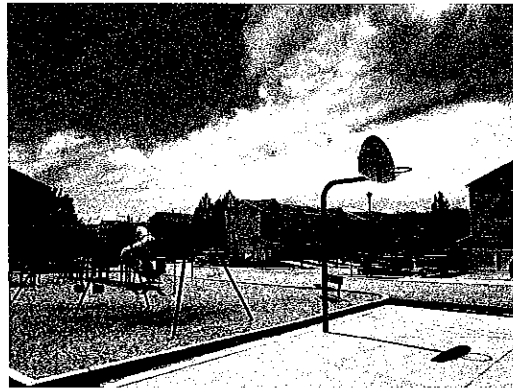
Park Equipment-Basketball Backboard, Rpl - 2020

Asset ID	1008	1 unit	@ \$715.00
		Asset Cost	\$715.00
		Percent Replacement	100%
		Future Cost	\$837.74
Placed in Service	Park January 1999		
Useful Life	20		
Adjustment	1		
Replacement Year	2020		
Remaining Life	8

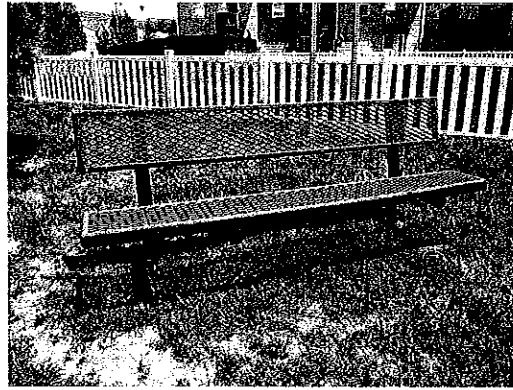
Park Equipment-Benches, 6', Repl continued...

Asset ID	1007	5 benches	@ \$540.00
		Asset Cost	\$2,700.00
		Percent Replacement	100%
		Future Cost	\$3,163.48
Placed in Service	Park January 1999		
Useful Life	20		
Adjustment	1		
Replacement Year	2020		
Remaining Life	8

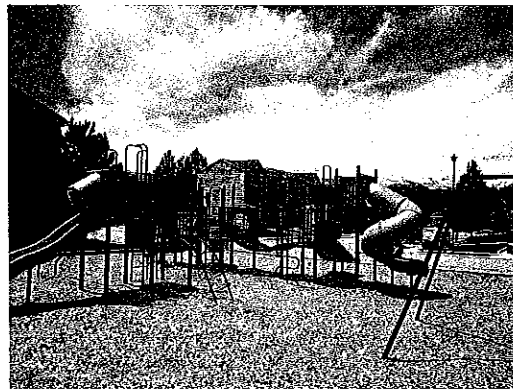
Playground Equipment - Play Platform, Repl - 2020

Asset ID	1019	1 set @	\$13,260.00
		Asset Cost	\$13,260.00
		Percent Replacement	100%
		Future Cost	\$15,536.20
Placed in Service	Park January 1999		
Useful Life	20		
Adjustment	1		
Replacement Year	2020		
Remaining Life	8

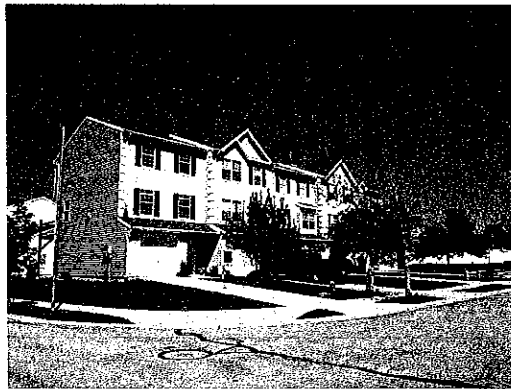
Landscape-Common Areas, Rpl

Asset ID	1012	1 total @ \$25,000.00
		Asset Cost \$25,000.00
		Percent Replacement 100%
		Future Cost \$174,083.18
Placed in Service	Landscape January 2011	
Useful Life	99	
Replacement Year	2110	
Remaining Life	98

The cost estimates on this asset have been provided by the client and incorporated into our report at their request. Due to the nature and size of this expense, we have excluded funding for this component. We anticipate any expenditures will be covered by the operational budget and have listed this component for inventory purposes only.

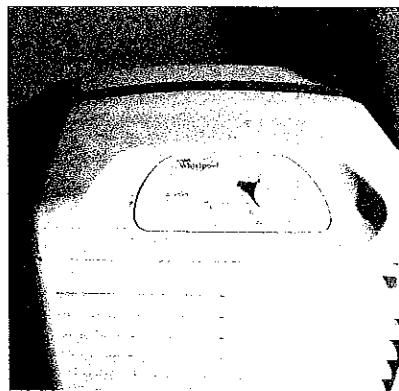
Humidifier-Pump House, Rpl. - 2019

Asset ID	1021	1 unit	@ \$3,500.00
		Asset Cost	\$3,500.00
		Percent Replacement	100%
		Future Cost	\$4,020.40
Placed in Service	Equipment		
Useful Life	January 1999		
	20		
Replacement Year	2019		
Remaining Life	7

This is an rough estimate.

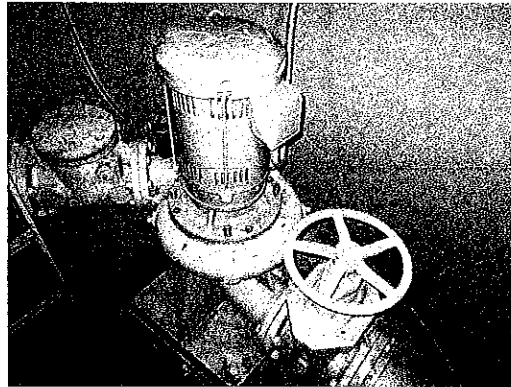
Pumps-Repair - 2014

Asset ID	1014	2 pumps	@ \$2,000.00
		Asset Cost	\$4,000.00
		Percent Replacement	100%
		Future Cost	\$4,161.60
Placed in Service	Equipment		
Useful Life	January 2010		
	4		
Replacement Year	2014		
Remaining Life	2

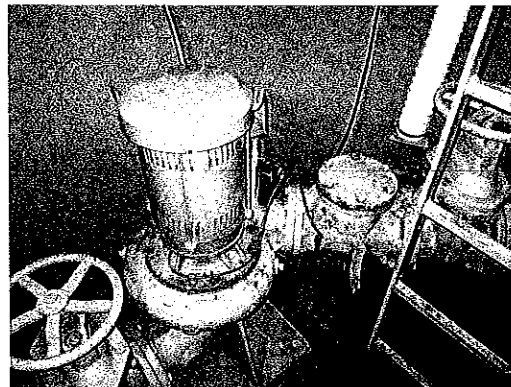
Pumps-Replace - 2022

Asset ID	1013	1 total	@ \$19,030.00
		Asset Cost	\$19,030.00
		Percent Replacement	100%
		Future Cost	\$23,197.46
Placed in Service	Equipment		
Useful Life	January 2010		
	12		
Replacement Year	2022		
Remaining Life	10

2 - pumps, 5 hp @ \$8,015.00 = \$16,030.00

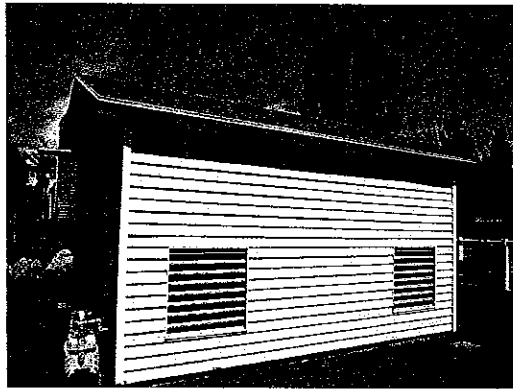
Siding-Vinyl, Pump House, Rpl - 2024

420 sq.ft.	@ \$4.75
Asset ID	1006	Asset Cost	\$1,995.00
		Percent Replacement	100%
		Future Cost	\$2,530.14
	Building Components		
Placed in Service	January 1999		
Useful Life	24		
Adjustment	1		
Replacement Year	2024		
Remaining Life	12
